**CANADIAN FORCES
FLIGHT SAFETY INVESTIGATION REPORT

FINAL REPORT**

FILE NUMBER: 1010-C-GTHL (DFS 2-3-3)
DATE OF REPORT: 15 October 2004

AIRCRAFT TYPE: Cessna 172
DATE/TIME: 14 1430Z/1130 Local August 2003
LOCATION: Fredericton, New Brunswick
CATEGORY: "C" Category Accident

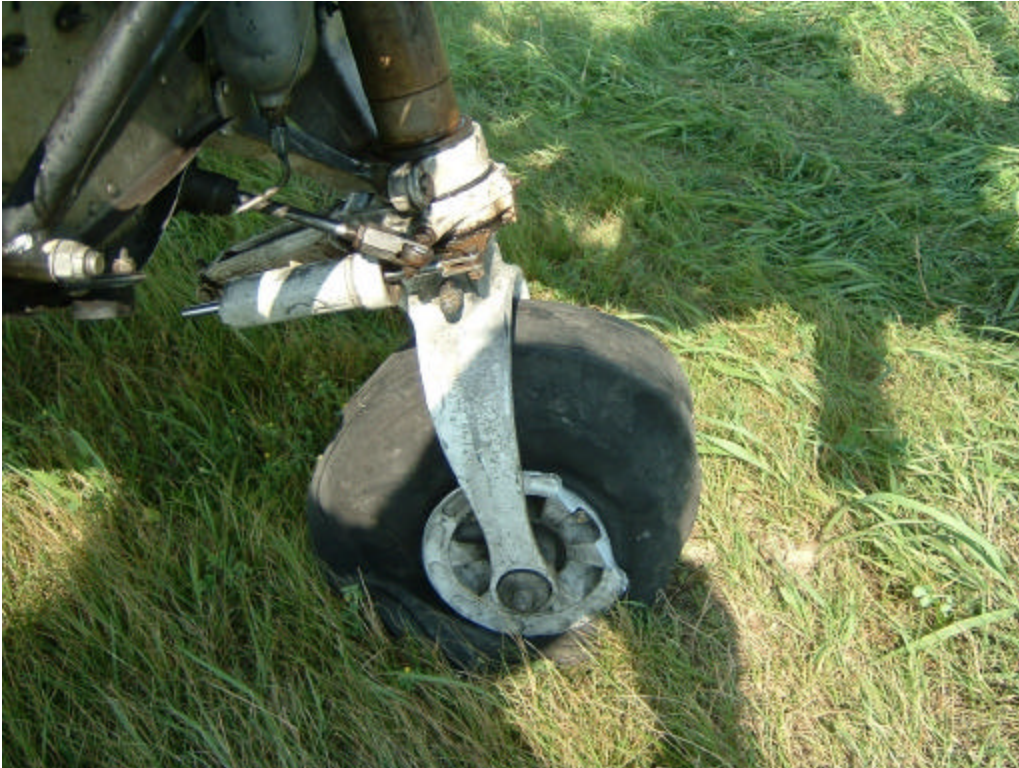
The nose wheel tire ruptured and the wheel rim edges shattered (Annex A - Photo 1). The nose wheel oleo end-cap was pushed off after a retaining bolt failed. There was warping of both the firewall and the cabin floorboard panels. (Annex A - Photos 2 and 3). The propeller and engine were undamaged.

Nose wheel rim fragments were sent to Quality Engineering Test Establishment (QETE) for failure analysis. Results indicated that the rim fractured under overload conditions.

Photo 1: Nose Wheel Damage

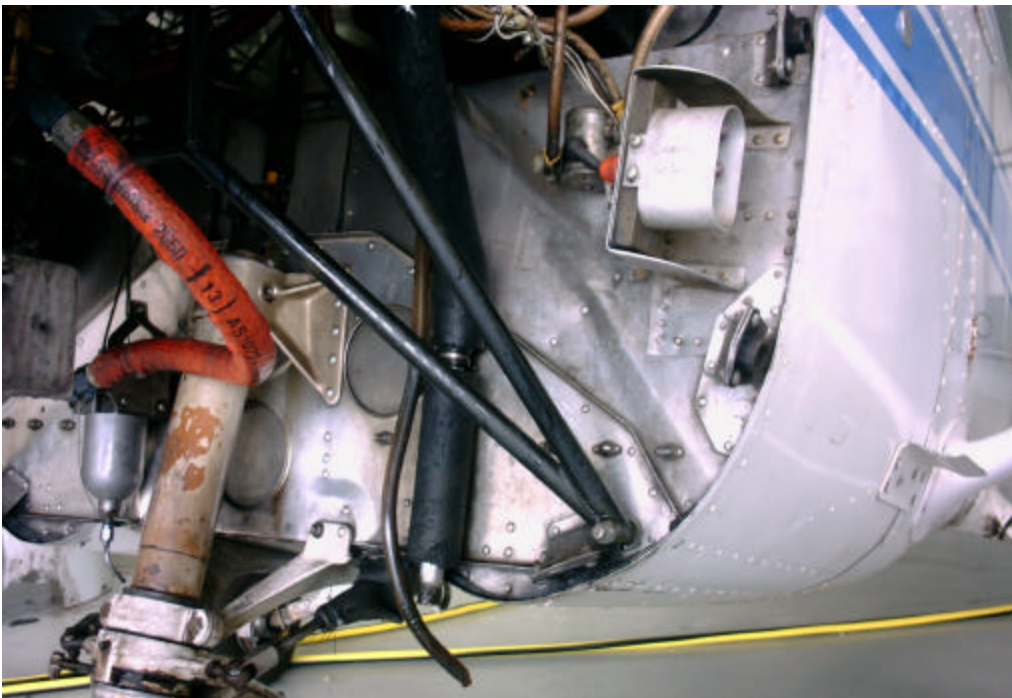
Photo 2: Firewall Warping

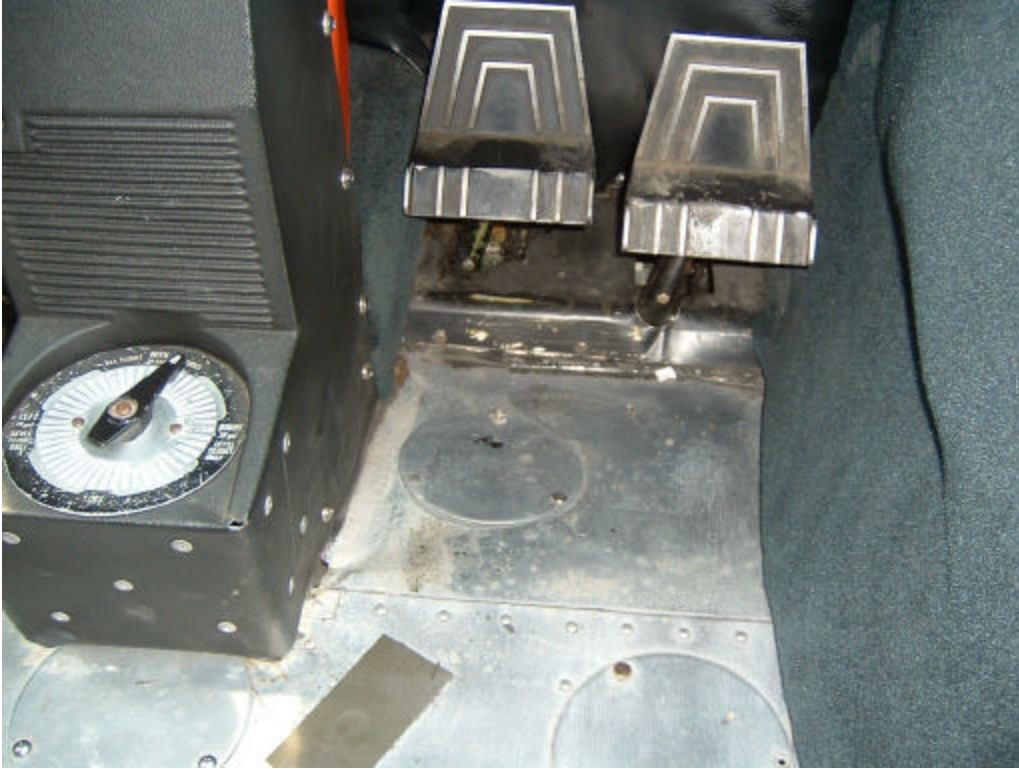
Photo 3: Floorboard Warping
